US Army Corps
of Engineers

CONTRACT REPORT EL-89-3

RESERVOIR BANK EROSION AND CULTURAL
RESOURCES: EXPERIMENTS IN MAPPING AND
PREDICTING THE EROSION OF ARCHEOLOGICAL
SEDIMENTS AT RESERVOIRS ALONG THE
MIDDLE MISSOURI RIVER WITH SEQUENTIAL
HISTORICAL AERIAL PHOTOGRAPHS

Final Report

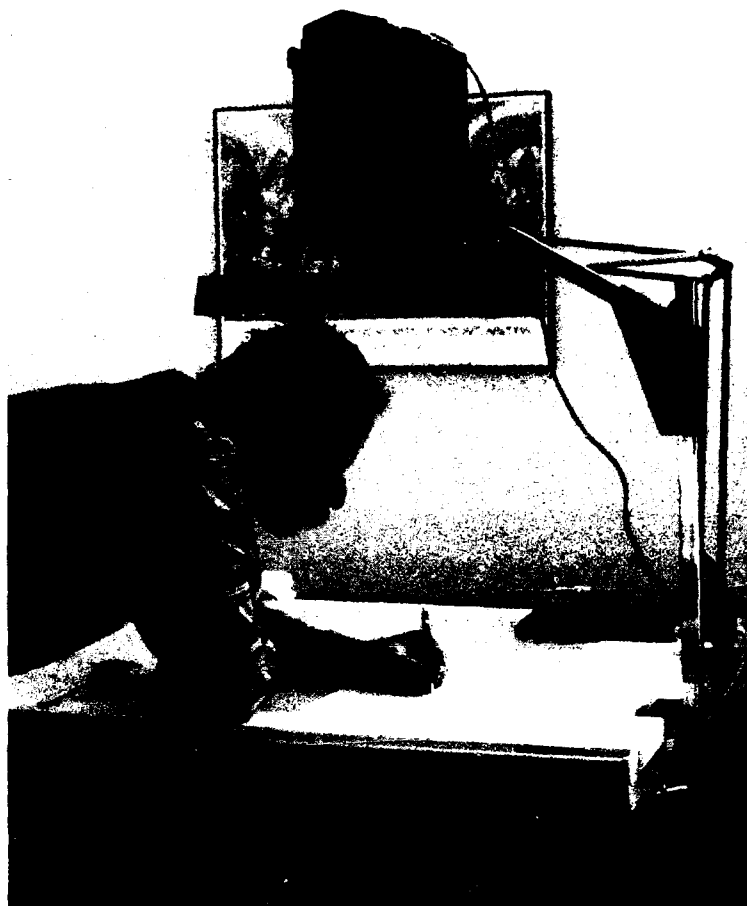
Figure 3. Projecting interpreted bank lines to scale and rectification with a Map-O-Graph opaque projector

- f. Projection of bank lines to base map scale. Each photointerpretive overlay was next projected to 1:10,000 scale using a Map-O-Graph opaque projector with a special flat field lens. This was accomplished by matching chosen photo control points against their corresponding locations on the 1:10,000-scale base map and redrafting the bank line at the base map scale (Figure 3).

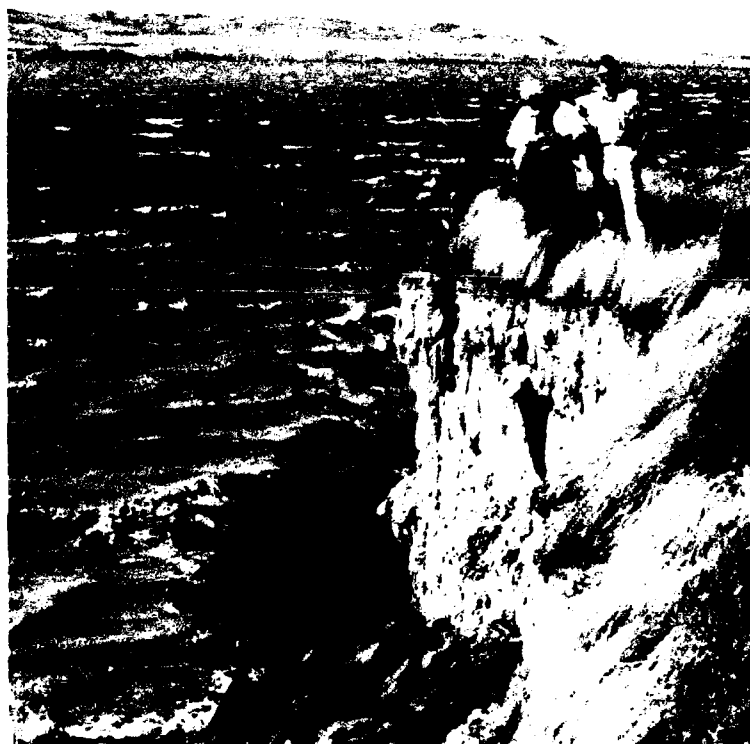
Figure 7. Sediments recently collapsed probably due to topple or cantilever failure of jointed silty sediments at the Jones Village Site, 39CA1

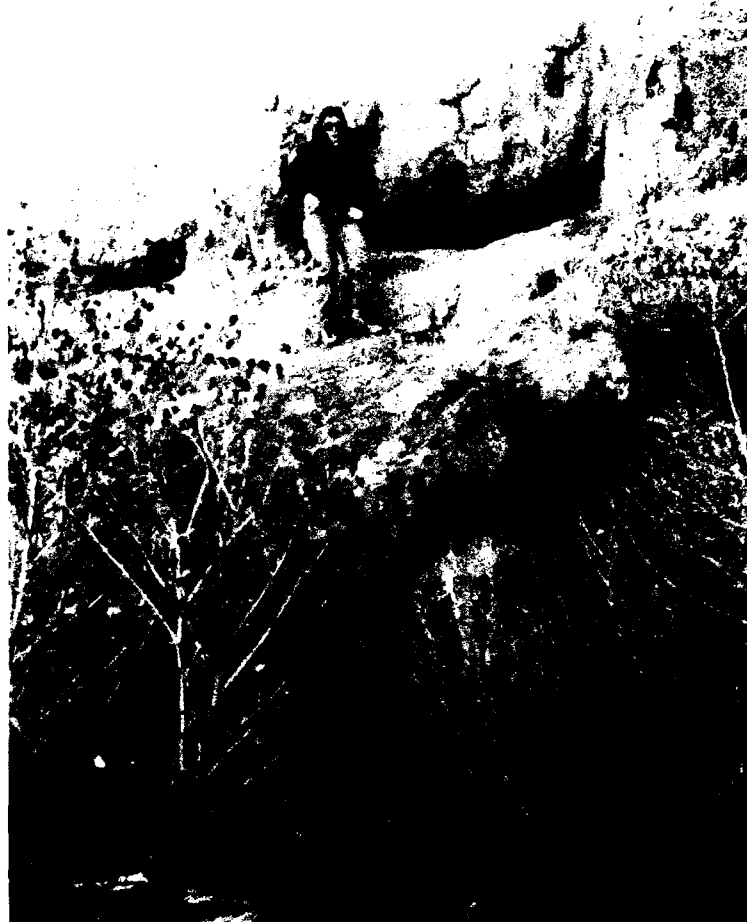
Figure 12. Systematic and widespread undermining of banks during illegal looting activities may be a major factor facilitating bank collapse and erosion at some sites

(Figure 12). Looters remove astonishingly large amounts of sediment and undermine banks very effectively at some sites, and this activity occurs year after year. Illegal artifact collecting, then, poses a double threat to cultural resources. This is one cause of bank erosion that would be relatively easy to combat and control (Site 39C06).

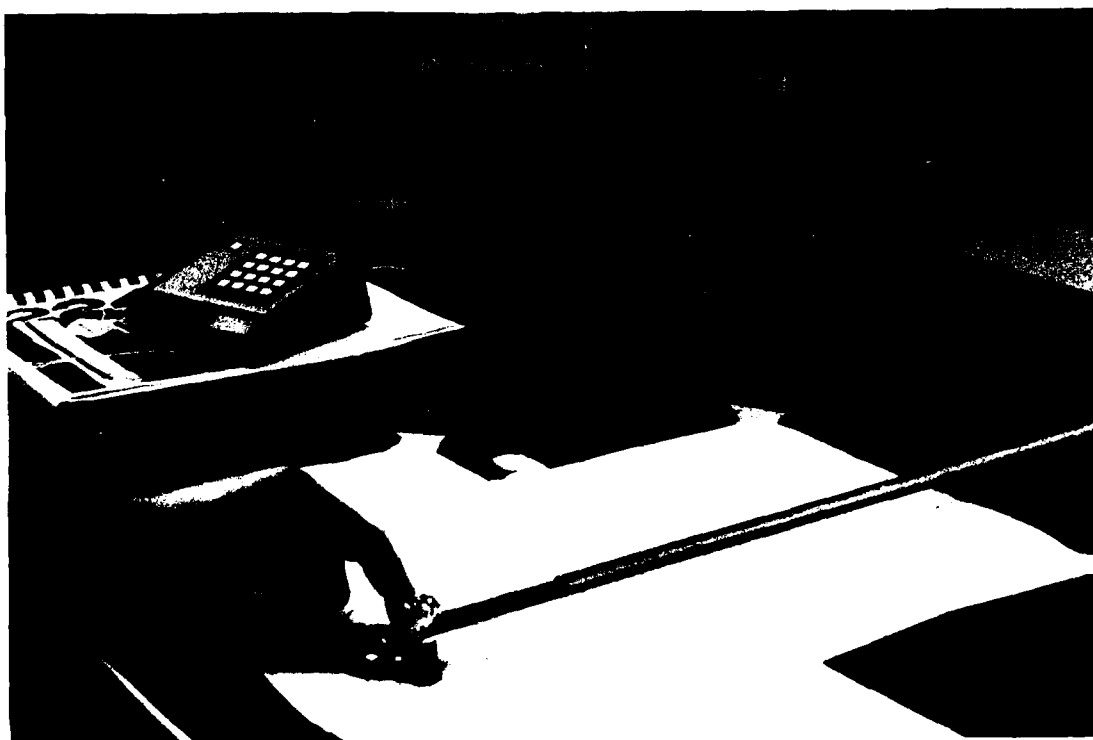
Figure 30. Measurement of areas of sites lost using a Numonics digital planimeter

190. A digital planimeter was used to measure the areas of the sites as they were prior to reservoir filling, and the successive amounts of site area lost due to bank recession at later dates (Figure 30). It should be mentioned here that defining the boundaries of a site is, in almost all cases, a rather arbitrary exercise, whether it is done using evidence visible on aerial photographs or through survey or excavation on the ground. In the three experimental cases illustrated here, site boundaries were defined on the basis of cultural features that could be cumulatively photointerpreted from the aerial photographs--the maximum extent of fortification ditches and housepits, for
